# Access Compliance Report Public Rights-of-Way (Curb Ramps)

Main Street: **HAMER\_LN** Cross Street: **CASTLEFIELD\_DR** Location: **NE**

ADA ID: **RPRK210917124130** Ramp Type: **Type 1 - Perpendicular Diagonal** Initial Pass/Fail: **Pass** Overall Compliance: **No** Severity Score: **0**

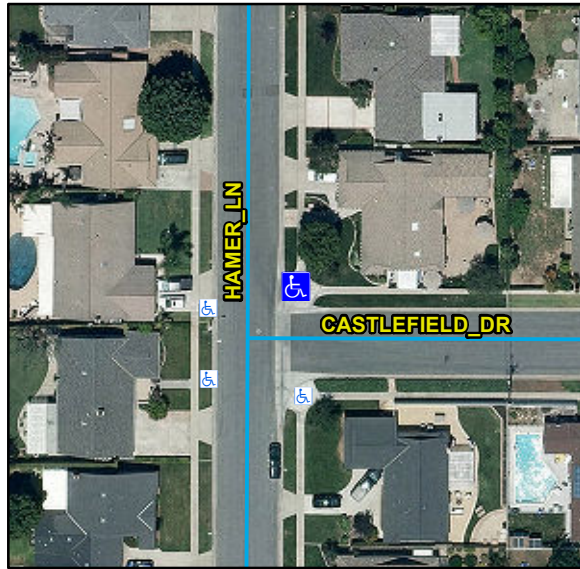
| Compliance | Description | Data | Compliance | Description | Data |
|---|---|---|---|---|---|
| <b>Yes</b> | Gutter Ponding | <b>No</b> | <b>No</b> | Curb Slope | <b>8.6</b> |
| <b>No</b> | Gutter Cross Slope (%) | <b>3.8</b> | | | |

**Remove & Replace Curb Ramp With Two New Directional Ramps or Equivalent. Remove & Replace Gutter.**
