# Access Compliance Report Public Rights-of-Way (Curb Ramps)

Main Street: CASTLEFIELD\_DR Cross Street: HAMER\_LN Location: SE

ADA ID: RPRK210917125220 Ramp Type: Type 1 - Perpendicular Diagonal Initial Pass/Fail: Pass Overall Compliance: No Severity Score: 2

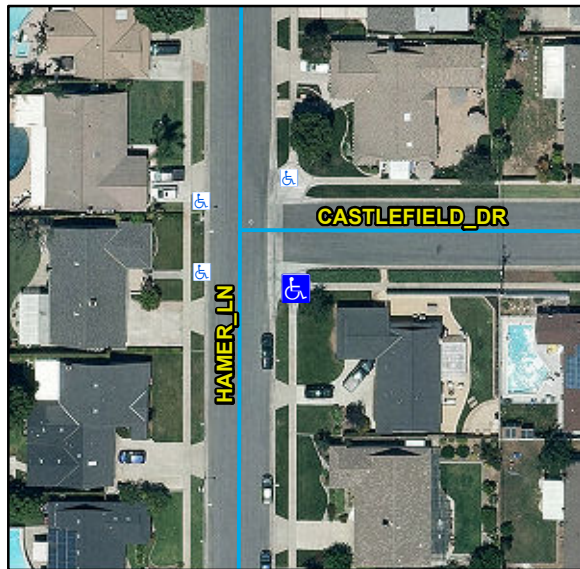
| Compliance | Description | Data | Compliance | Description | Data |
|---|---|---|---|---|---|
| No | Ramp Cross Slope (%) | 4 | N/A | Flare Traversable LT | No |
| No | Landing Run Slope (%) | 3.6 | N/A | Flare Traversable RT | No |
| Yes | Gutter Ponding | No | No | Curb Slope | 13.9 |

**Remove & Replace Curb Ramp With Two New Directional Ramps or Equivalent.**
