# Access Compliance Report Public Rights-of-Way (Curb Ramps)

Main Street: ROCKAWAY\_DR Cross Street: CEDARLAWN\_DR Location: SE

ADA ID: RPRK210917131650 Ramp Type: Type 1 - Perpendicular Diagonal Initial Pass/Fail: Fail Overall Compliance: No Severity Score: 2

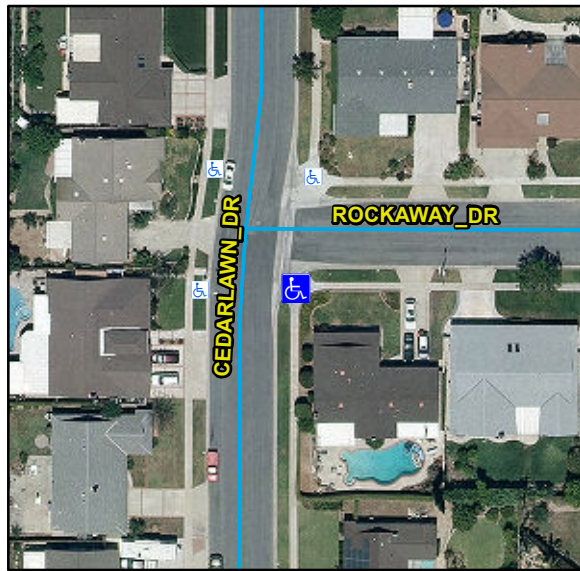
| Compliance | Description | Data | Compliance | Description | Data |
|---|---|---|---|---|---|
| No | Ramp Cross Slope (%) | 2.6 | N/A | Flare Traversable LT | N/A |
| N/A | Gutter Ponding | N/A | No | Curb Slope | 10.7 |

Remove & Replace Curb Ramp With Two New Directional Ramps or Equivalent.

R304.2.2, R304.5.3, STD 1115
