# Access Compliance Report Public Rights-of-Way (Curb Ramps)

Main Street: SKYMEADOW\_DR Cross Street: CEDARLAWN\_DR Location: SE

ADA ID: RPRK210917133041 Ramp Type: Type 1 - Perpendicular Diagonal Initial Pass/Fail: Fail Overall Compliance: No Severity Score: 2

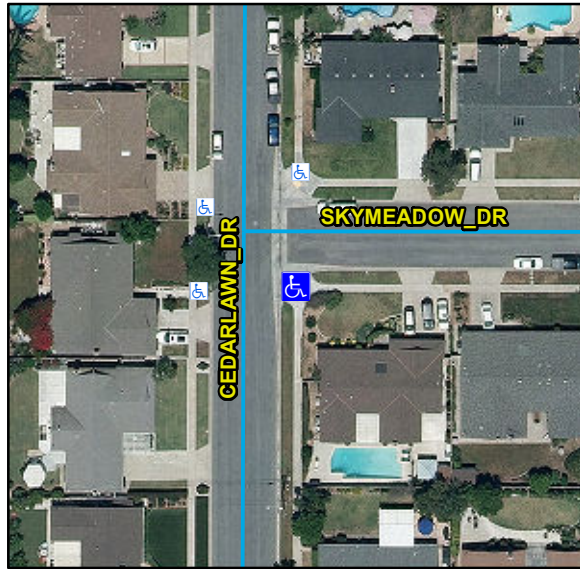
| Compliance | Description | Data | Compliance | Description | Data |
|---|---|---|---|---|---|
| No | Ramp Cross Slope (%) | 2.2 | N/A | Flare Traversable LT | N/A |
| N/A | Gutter Ponding | N/A | No | Curb Slope | 7.7 |

**Remove & Replace Curb Ramp With Two New Directional Ramps or Equivalent.**

**R304.2.2, R304.5.3, STD 1115**
