# Access Compliance Report Public Rights-of-Way (Curb Ramps)

Main Street: MC\_KENZIE\_DR Cross Street: ROCKAWAY\_DR Location: NE

ADA ID: RPRK210917135644 Ramp Type: Type 1 - Perpendicular Diagonal Initial Pass/Fail: Pass Overall Compliance: No Severity Score: 4

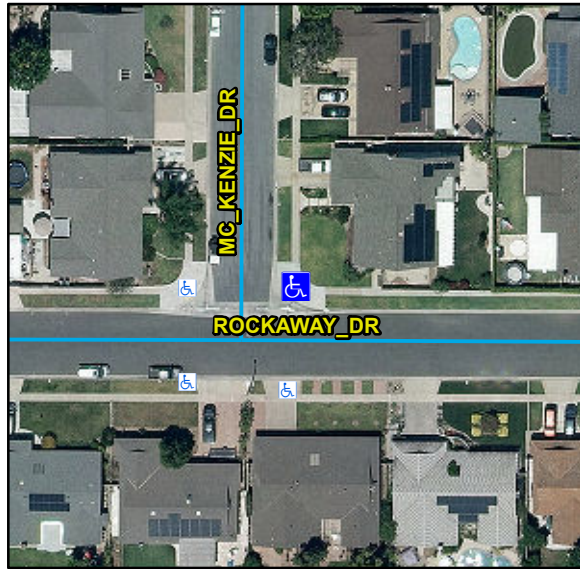
## Field Measurements/Component Compliance

Remove & Replace Curb Ramp With Two New Directional Ramps or Equivalent.

R304.2.2, R304.2.1, STD 1115
