# Access Compliance Report Public Rights-of-Way (Curb Ramps)

Main Street: ROCKAWAY\_DR Cross Street: MC\_KENZIE\_DR Location: NW

ADA ID: RPRK210917140237 Ramp Type: Type 1 - Perpendicular Diagonal Initial Pass/Fail: Pass Overall Compliance: No Severity Score: 4

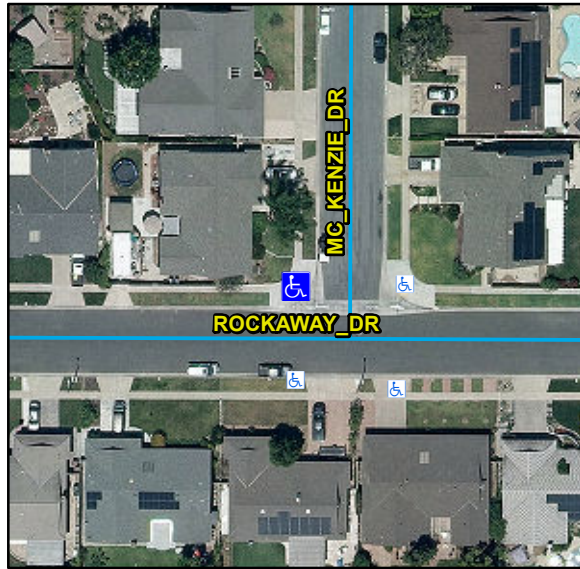
R304.2.2, R304.2.1, STD 1115

| Compliance | Description | Data | Compliance | Description | Data |
|---|---|---|---|---|---|
| Yes | Gutter Ponding | No | No | Curb Slope | 9.2 |

Remove & Replace Curb Ramp With Two New Directional Ramps or Equivalent.
