# Access Compliance Report Public Rights-of-Way (Curb Ramps)

Main Street: **HAMER\_DR** Cross Street: **CARTLEN\_DR** Location: **NE**

ADA ID: **RPRK210917152521** Ramp Type: **Type 1 - Perpendicular Diagonal Initial Pass/Fail: Fail** Overall Compliance: **No** Severity Score: **2**

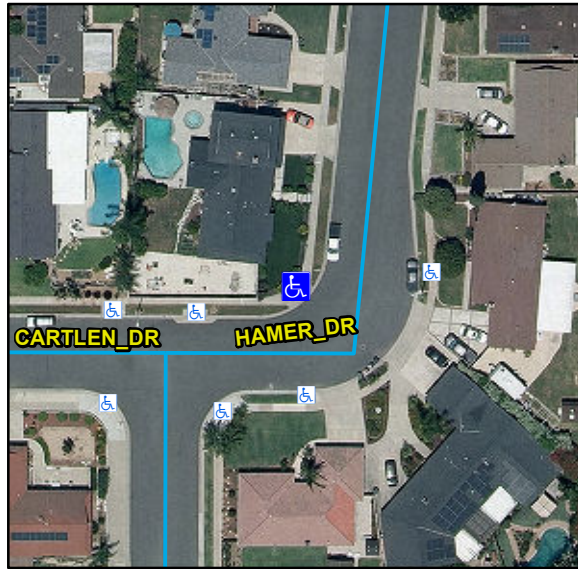
| Compliance | Description | Data | Compliance | Description | Data |
|---|---|---|---|---|---|
| No | Ramp Cross Slope (%) | 3.5 | N/A | Flare Traversable LT | N/A |

**Remove & Replace Curb Ramp With Two New Directional Ramps or Equivalent.**

**R304.2.2, R304.5.3, STD 1115**
