# Access Compliance Report Public Rights-of-Way (Curb Ramps)

Main Street: CARTLEN\_DR Cross Street: HAMER\_DR Location: NW

ADA ID: RPRK210917152944 Ramp Type: Type 1 - Perpendicular Initial Pass/Fail: Pass Overall Compliance: No Severity Score: 16

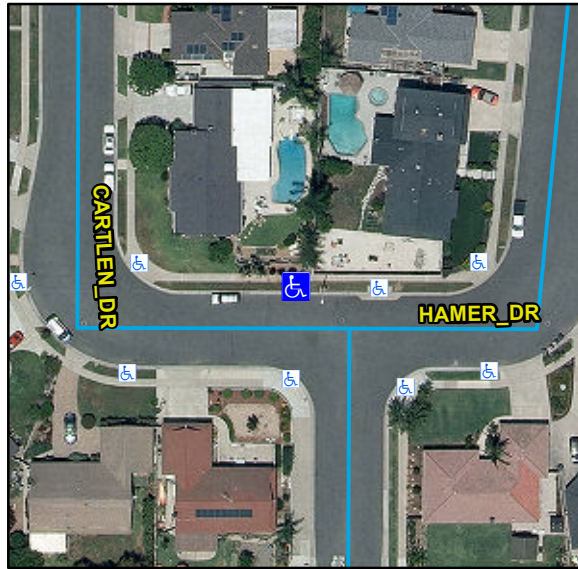
| Compliance | Description | Data | Compliance | Description | Data |
|---|---|---|---|---|---|
| Yes | Landing Cross Slope (%) | 0.3 | No | DWS Provided | No |
| No | Gutter Ponding | Yes | No | Curb Slope | 9.7 |
| No | Gutter Cross Slope (%) | 8.7 | | | |

Remove & Replace Entire Ramp. Remove & Replace Gutter.

R304.2.2, R304.2.1, R305, R302.7, R304.5.3, STD 1115

Total Cost: \$ 3332
