# Access Compliance Report Public Rights-of-Way (Curb Ramps)

Main Street: HAMER\_DR Cross Street: TABAH\_LN Location: SW

ADA ID: RPRK210917154648 Ramp Type: Type 1 - Perpendicular Diagonal Initial Pass/Fail: Pass Overall Compliance: No Severity Score: 6

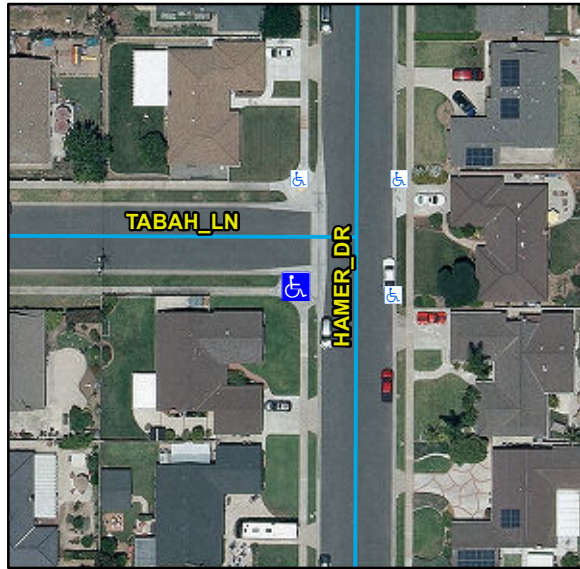
| Compliance | Description | Data | Compliance | Description | Data |
|---|---|---|---|---|---|
| No | Gutter Ponding | Yes | No | Curb Slope | 7.9 |

Remove & Replace Curb Ramp With Two New Directional Ramps or Equivalent.

R304.2.2, R304.2.1, R302.7, STD 1115
