# Access Compliance Report Public Rights-of-Way (Curb Ramps)

Main Street: TABAH\_LN Cross Street: HAMER\_DR Location: NW

ADA ID: RPRK210917155309 Ramp Type: Type 1 - Perpendicular Diagonal Initial Pass/Fail: Pass Overall Compliance: No Severity Score: 8

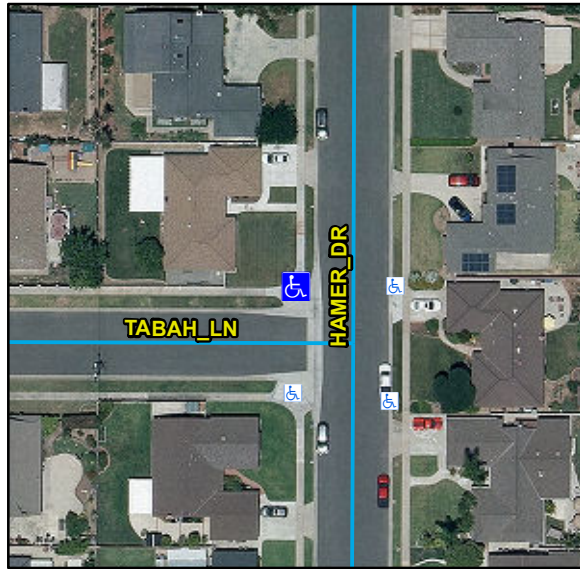
| Compliance | Description | Data | Compliance | Description | Data |
|---|---|---|---|---|---|
| Yes | Gutter Ponding | No | No | Curb Slope | 9.8 |
| No | Gutter Cross Slope (%) | 4 | | | |

**Remove & Replace Curb Ramp With Two New Directional Ramps or Equivalent. Remove & Replace Gutter.**

**R304.2.2, R304.2.1, R304.5.3, STD 1115**
