# Access Compliance Report Public Rights-of-Way (Curb Ramps)

Main Street: MCCORMACK\_LN Cross Street: SHADBURN\_AVE Location: SW

ADA ID: RPRK210917160126 Ramp Type: Type 1 - Perpendicular Diagonal Initial Pass/Fail: Fail Overall Compliance: No Severity Score: 0

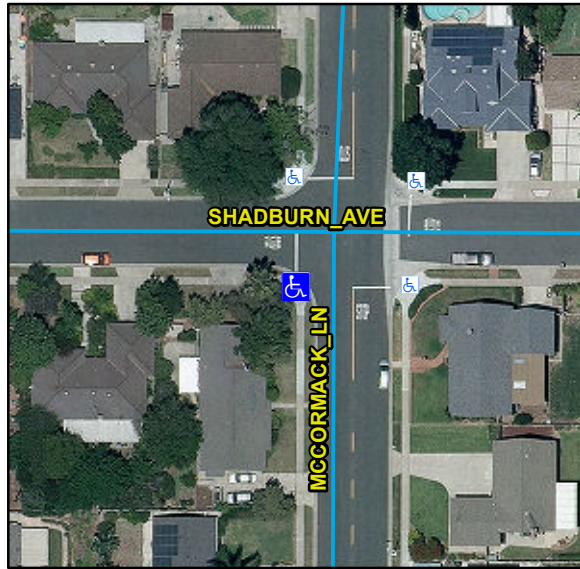
## Field Measurements/Component Compliance

**Remove & Replace Curb Ramp With Two New Directional Ramps or Equivalent.**

**R304.2.2, STD 1115**
