Access Compliance Report Public Rights-of-Way (Curb Ramps)

Main Street: MCCORMACK LN **Cross Street: SHADBURN AVE** Location: NE

ADA ID: RPRK210917161354 Ramp Type: Type 1 - Perpendicular Diagonal Initial Pass/Fail: Pass **Overall Compliance: No**

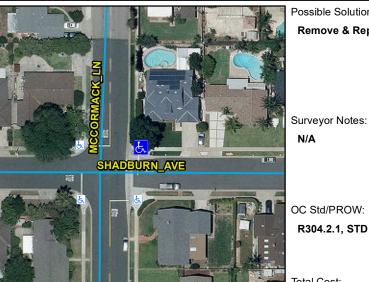
Field Measurements/Component Compliance							
	Com	pliance Description	Data	Com	pliance Description	Data	
	N/A	Ramp Length (in)	101	N/A	Flare Type LT		
	Yes	Ramp Width (in)	48			Sloped	
	Yes	Ramp Run Slope (%)	3.3	N/A	Flare Slope LT (%)	7.9	
	Yes	Ramp Cross Slope (%)	0.6	N/A	Flare Traversable LT	No	
	N/A	Landing Present	Yes	N/A	Flare Type RT		
	N/A	Landing Length (in)	35			Sloped	
	Yes	Landing Width (in)	48	N/A	Flare Slope RT (%)	7	
	Yes	Landing Run Slope (%)	2	N/A	Flare Traversable RT	No	
	Yes	Landing Cross Slope (%)	0.9	Yes	DWS Provided	Yes	
	N/A	Landing Movement Obstructed?	Yes	Yes	DWS Contrast	Yes	
		Landing Movement Type	Curb	Yes	DWS Length (in)	36	
	N/A	Landing Shared	No	Yes	DWS Full Width	Yes	
	N/A	Clear Space	Yes	Yes	DWS Offset Left (in)	0	
	N/A	Clear Space To Crosswalk (in)	48	Yes	DWS Offset Right (in)	N/A	
531	N/A	Marked Crosswalk 1	No	N/A	Marked Crosswalk 2	No	
		Crossing 1 Direction	W		Crossing 2 Direction	S

Remove & Replace Landing.

R304.2.1, STD 1115
