# Access Compliance Report Public Rights-of-Way (Curb Ramps)

Main Street: SHADBURN\_AVE Cross Street: KERMATH\_ST Location: SE

ADA ID: RPRK210917164536 Ramp Type: Type 1 - Perpendicular Diagonal Initial Pass/Fail: Fail Overall Compliance: No Severity Score: 0

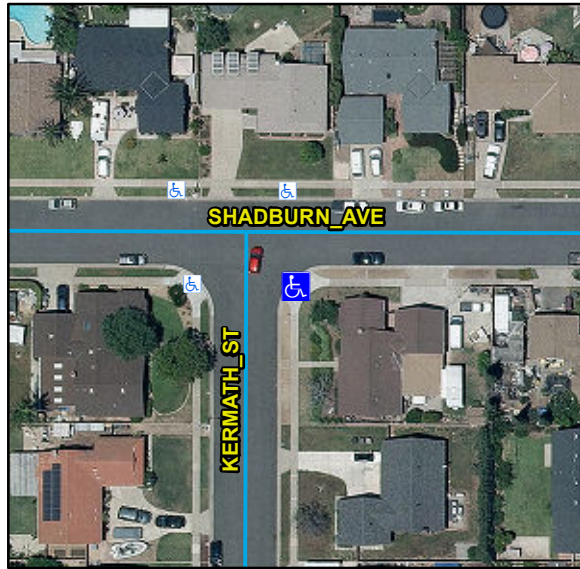
## Field Measurements/Component Compliance

**Remove & Replace Curb Ramp With Two New Directional Ramps or Equivalent.**

**R304.2.2, STD 1115**
