# Access Compliance Report Public Rights-of-Way (Curb Ramps)

Main Street: SANBERT\_ST Cross Street: SHADBURN\_AVE Location: SW

ADA ID: RPRK210917165724 Ramp Type: Type 1 - Perpendicular Diagonal Initial Pass/Fail: Fail Overall Compliance: No Severity Score: 0

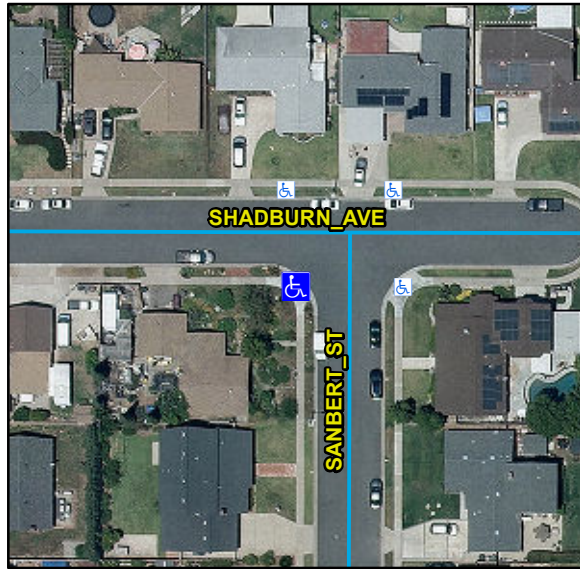
## Field Measurements/Component Compliance

Remove & Replace Curb Ramp With Two New Directional Ramps or Equivalent.

R304.2.2, STD 1115
