# Access Compliance Report Public Rights-of-Way (Curb Ramps)

Main Street: FRALEY\_ST Cross Street: KATELLA\_AVE Location: SW

ADA ID: RPRK210920120718 Ramp Type: Type 1 - Perpendicular Diagonal Initial Pass/Fail: Fail Overall Compliance: No Severity Score: 2

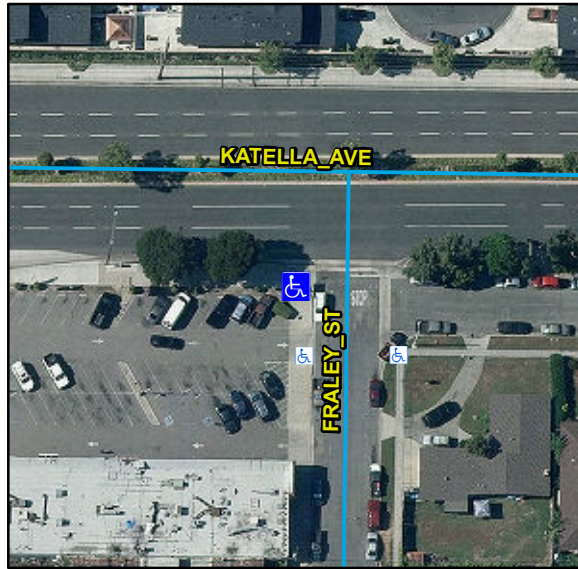
| Compliance | Description | Data | Compliance | Description | Data |
|---|---|---|---|---|---|
| No | Ramp Cross Slope (%) | 2.8 | N/A | Flare Traversable LT | N/A |

Remove & Replace Curb Ramp With Two New Directional Ramps or Equivalent.

R304.2.2, R304.5.3, STD 1115
