# Access Compliance Report Public Rights-of-Way (Curb Ramps)

Main Street: KATELLA\_AVE Cross Street: FRALEY\_ST Location: SE

ADA ID: RPRK210920121742 Ramp Type: Type 4 - Parallel Initial Pass/Fail: Pass Overall Compliance: No Severity Score: 0

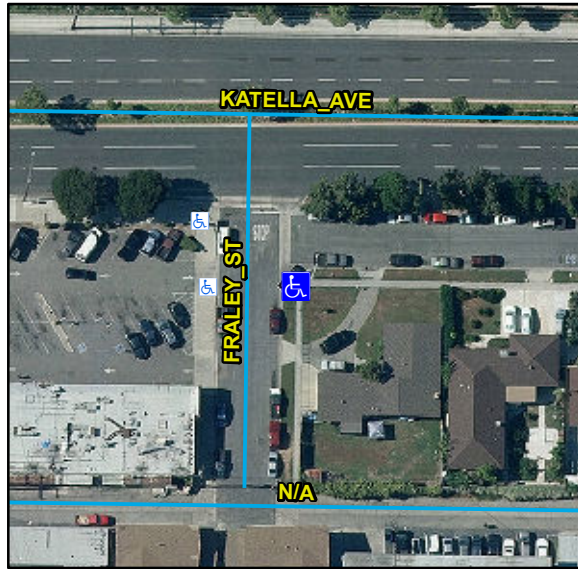
## Field Measurements/Component Compliance

Possible Solutions:

**Remove & Replace Curb Ramp With Two New Directional Ramps or Equivalent. Utility Present.**

**R204.3, STD 1115**

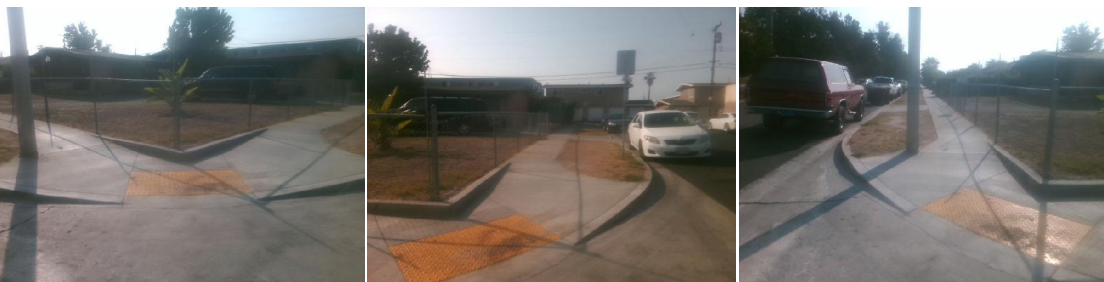
| Compliance | Description | Data | Compliance | Description | Data |
|---|---|---|---|---|---|
| Yes | Overall Surface Condition | Acceptable | | | |
| | Cross Gutter Present? | Yes | | Spandrel Present? | Yes |
| | Replace Cross Gutter? | No | | Replace Spandrel? | No |
