Access Compliance Report Public Rights-of-Way (Curb Ramps)

Main Street: **KATELLA_AVE** Cross Street: **N/A** Location: **SE**

ADA ID: **RPRK210920124019** Ramp Type: **Type 1 - Perpendicular Diagonal Initial Pass/Fail: Fail** Overall Compliance: **No** Severity Score: **15**

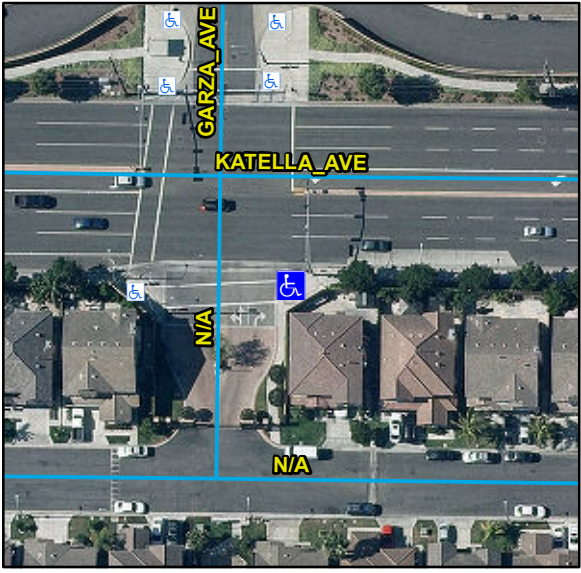
Compliance	Description	Data	Compliance	Description	Data
N/A	Ramp Length (in)	117	N/A	Flare Type LT	
Yes	Ramp Width (in)	48			N/A
Yes	Ramp Run Slope (%)	6.1	N/A	Flare Slope LT (%)	N/A
No	Ramp Cross Slope (%)	5.2	N/A	Flare Traversable LT	N/A
N/A	Landing Present	N/A	N/A	Flare Type RT	
N/A	Landing Length (in)	N/A			N/A
N/A	Landing Width (in)	N/A	N/A	Flare Slope RT (%)	N/A
N/A	Landing Run Slope (%)	N/A	N/A	Flare Traversable RT	N/A
N/A	Landing Cross Slope (%)	N/A	N/A	DWS Provided	N/A
N/A	Landing Movement Obstructed?	N/A	N/A	DWS Contrast	N/A
	Landing Movement Type	N/A	N/A	DWS Length (in)	N/A
N/A	Landing Shared	N/A	N/A	DWS Full Width	N/A
N/A	Clear Space	Yes	N/A	DWS Offset Left (in)	N/A
N/A	Clear Space To Crosswalk (in)	N/A	N/A	DWS Offset Right (in)	N/A
N/A	Marked Crosswalk 1	No	N/A	Marked Crosswalk 2	No
	Crossing 1 Direction	N		Crossing 2 Direction	W
	Marked Crosswalk 1 Width (in)	N/A		Marked Crosswalk 2 Width (in)	N/A

Possible Solutions:
Remove & Replace Curb Ramp With Two New Directional Ramps or Equivalent.

OC Std/PROW:
R304.2.2, R304.5.3, STD 1115
