# Access Compliance Report Public Rights-of-Way (Curb Ramps)

Main Street: N/A Cross Street: KATELLA\_AVE Location: SW

ADA ID: RPRK210920125420 Ramp Type: Type 1 - Perpendicular Diagonal Initial Pass/Fail: Pass Overall Compliance: No Severity Score: 24

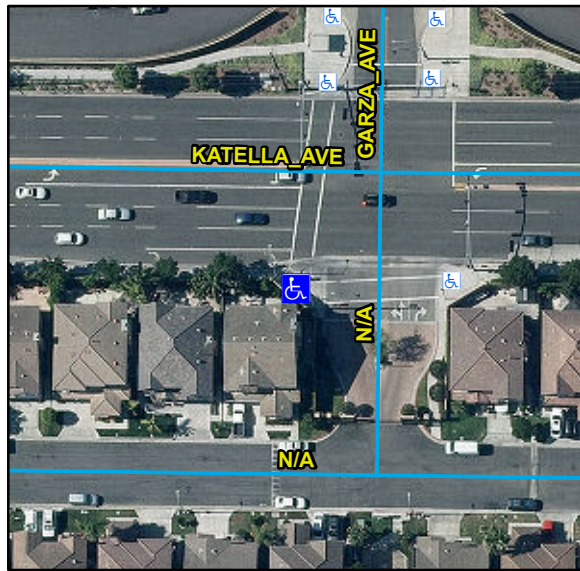
| Compliance | Description | Data | Compliance | Description | Data |
|---|---|---|---|---|---|
| No | Ramp Cross Slope (%) | 6.6 | N/A | Flare Traversable LT | No |
| No | Landing Run Slope (%) | 2.7 | N/A | Flare Traversable RT | No |
| No | Landing Cross Slope (%) | 6.6 | Yes | DWS Provided | Yes |
| No | Gutter Cross Slope (%) | 5.6 | | | |

Remove & Replace Curb Ramp With Two New Directional Ramps or Equivalent. Remove & Replace Gutter.

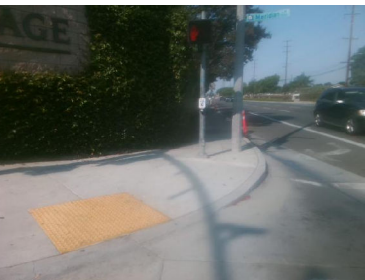
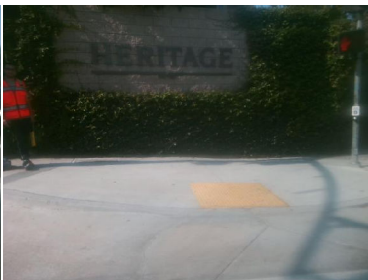
| Compliance | Description | Data | Compliance | Description | Data |
|---|---|---|---|---|---|
| | Landing Movement Type | Bush | Yes | DWS Length (in) | 36 |
