# Access Compliance Report Public Rights-of-Way (Curb Ramps)

Main Street: GARZA\_AVE Cross Street: KATELLA\_AVE Location: NE

ADA ID: RPRK210920133633 Ramp Type: Type 1 - Perpendicular Diagonal Initial Pass/Fail: Pass Overall Compliance: No Severity Score: 4

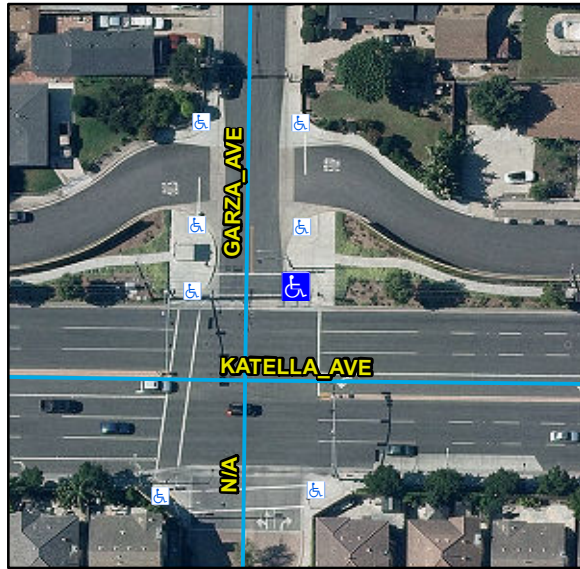
| Compliance | Description | Data | Compliance | Description | Data |
|---|---|---|---|---|---|
| No | Landing Run Slope (%) | 3.3 | N/A | Flare Traversable RT | No |

Possible Solutions:

Remove & Replace Landing.
