# Access Compliance Report Public Rights-of-Way (Curb Ramps)

Main Street: KATELLA\_AVE Cross Street: GARZA\_AVE Location: NW

ADA ID: RPRK210920134539 Ramp Type: Type 1 - Perpendicular Diagonal Initial Pass/Fail: Pass Overall Compliance: No Severity Score: 0

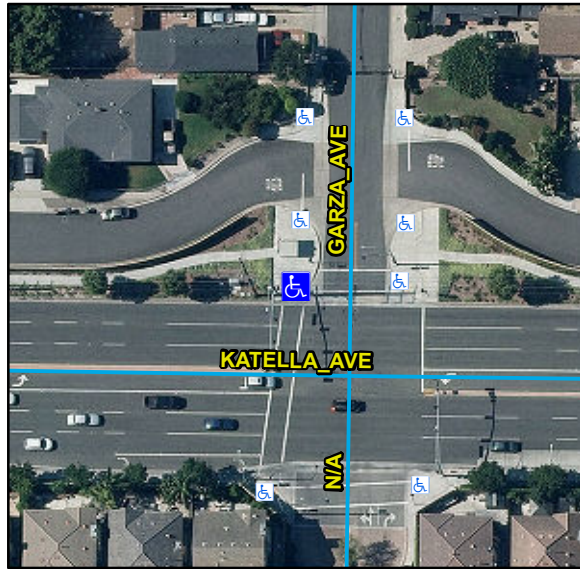
| Compliance | Description | Data | Compliance | Description | Data |
|---|---|---|---|---|---|
| No | Landing Cross Slope (%) | 2.4 | Yes | DWS Provided | Yes |

Possible Solutions:

Remove & Replace Landing.

OC Std/PROW:

R304.5.3, STD 1115

Total Cost:

\$ 531
