# Access Compliance Report Public Rights-of-Way (Curb Ramps)

Main Street: N/A Cross Street: GARZA\_AVE Location: E

ADA ID: RPRK210920141301 Ramp Type: Type 1 - Perpendicular Diagonal Initial Pass/Fail: Pass Overall Compliance: No Severity Score: 0

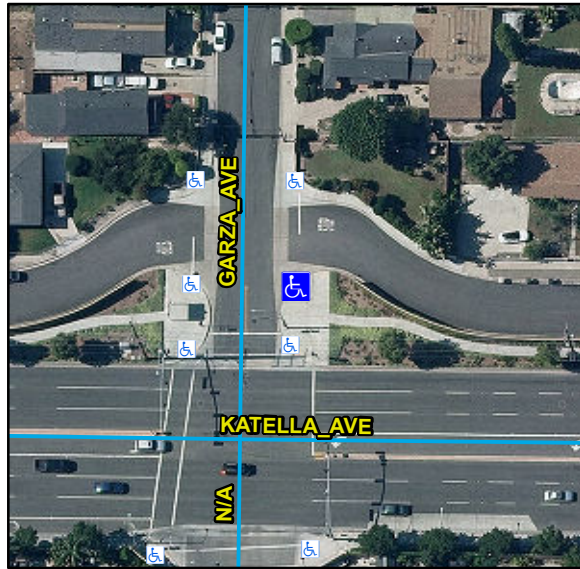
| Compliance | Description | Data | Compliance | Description | Data |
|---|---|---|---|---|---|
| No | Gutter Cross Slope (%) | 3.1 | | | |

Possible Solutions:

Remove & Replace Gutter.

R304.5.3, STD 1115
