# Access Compliance Report Public Rights-of-Way (Curb Ramps)

Main Street: GILBERT\_ST Cross Street: PACIFIC\_PL Location: SW

ADA ID: RPRK210920145319 Ramp Type: Type 1 - Perpendicular Diagonal Initial Pass/Fail: Fail Overall Compliance: No Severity Score: 2

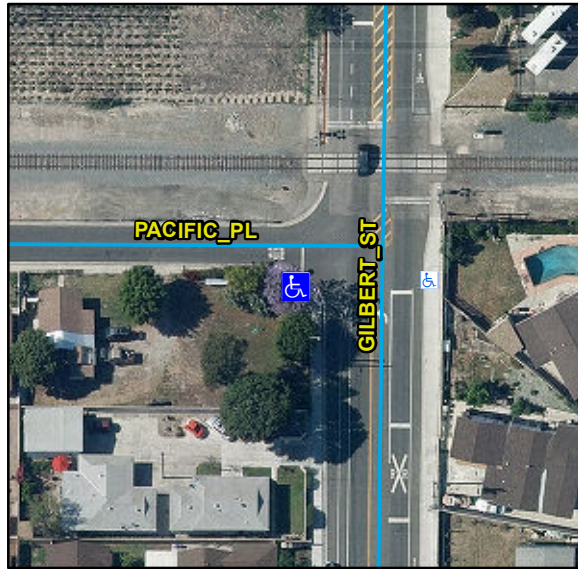
| Compliance | Description | Data | Compliance | Description | Data |
|---|---|---|---|---|---|
| No | Ramp Cross Slope (%) | 2.9 | N/A | Flare Traversable LT | N/A |

Remove & Replace Curb Ramp With Two New Directional Ramps or Equivalent.
