# Access Compliance Report Public Rights-of-Way (Curb Ramps)

Main Street: REGAL\_AVE Cross Street: RUSTIC\_LN Location: SE

ADA ID: RPRK210921105543 Ramp Type: Type 1 - Perpendicular Diagonal Initial Pass/Fail: Pass Overall Compliance: No Severity Score: 6

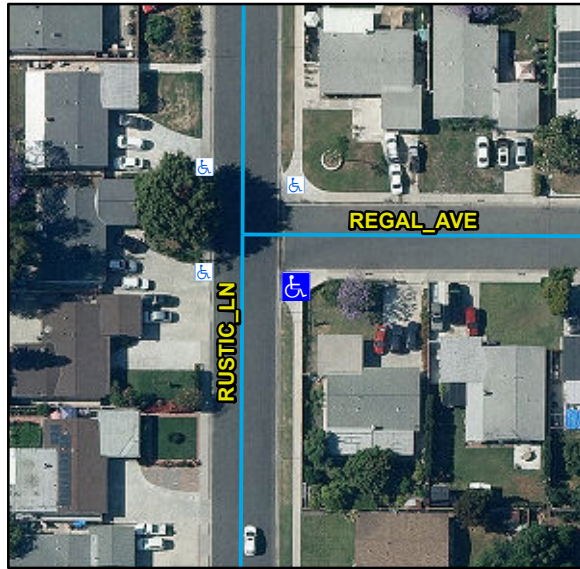
Remove & Replace Landing. Gutter Ponding Observed.

| Compliance | Description | Data | Compliance | Description | Data |
|---|---|---|---|---|---|
| No | Landing Run Slope (%) | 4.7 | N/A | Flare Traversable RT | Yes |
| No | Landing Cross Slope (%) | 2.5 | Yes | DWS Provided | Yes |
| No | Gutter Ponding | Yes | Yes | Curb Slope | 3.5 |

### Possible Solutions:
