# Access Compliance Report Public Rights-of-Way (Curb Ramps)

Main Street: RUSTIC\_LN Cross Street: REGAL\_AVE Location: E

ADA ID: RPRK210921110902 Ramp Type: Type 1 - Perpendicular Diagonal Initial Pass/Fail: Pass Overall Compliance: No Severity Score: 6

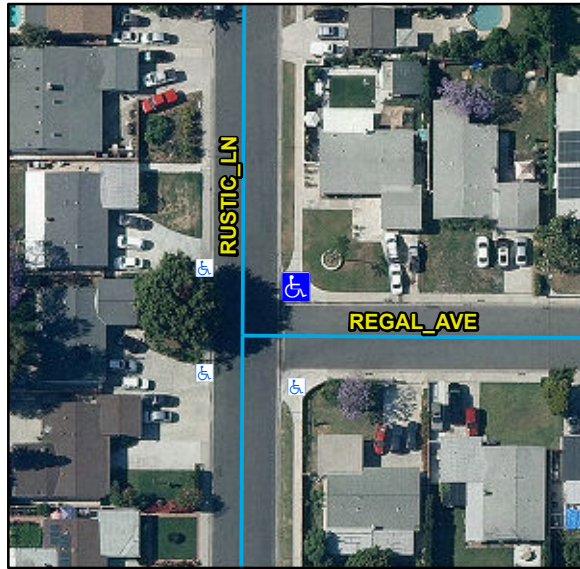
Remove & Replace Landing. Gutter Ponding Observed.

| Compliance | Description | Data | Compliance | Description | Data |
|---|---|---|---|---|---|
| No | Landing Run Slope (%) | 5 | N/A | Flare Traversable RT | Yes |
| No | Gutter Ponding | Yes | Yes | Curb Slope | 1.5 |

### Possible Solutions:

R304.2.1, R304.2.2-Perp, R304.3.2-Para, R302.7, STD 1115

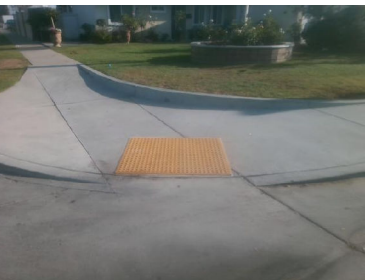
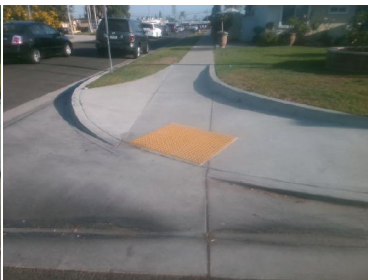
| Compliance | Description | Data | Compliance | Description | Data |
|---|---|---|---|---|---|
| Yes | Overall Surface Condition: Acceptable | | Yes | Perp Joint Present | Yes |
