# Access Compliance Report Public Rights-of-Way (Curb Ramps)

**Main Street: KATELLA\_AVE** **Cross Street: RUSTIC\_LN** **Location: NE**

**ADA ID: RPRK210921112036** **Ramp Type: Type 1 - Perpendicular Diagonal Initial Pass/Fail: Pass** **Overall Compliance: No** **Severity Score: 4**

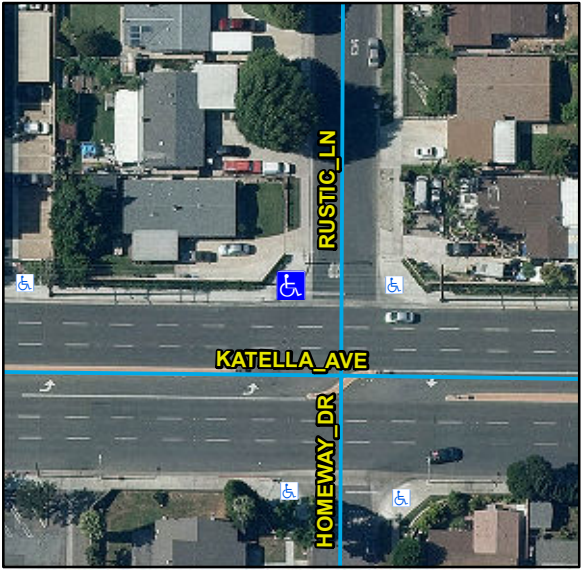
Compliance	Description	Data	Compliance	Description	Data
N/A	Ramp Length (in)	102	N/A	Flare Type LT	
Yes	Ramp Width (in)	48			Sloped
Yes	Ramp Run Slope (%)	1.5	Yes	Flare Slope LT (%)	8.6
Yes	Ramp Cross Slope (%)	0.9	N/A	Flare Traversable LT	Yes
N/A	Landing Present	Yes	N/A	Flare Type RT	
N/A	Landing Length (in)	36			Sloped
Yes	Landing Width (in)	48	N/A	Flare Slope RT (%)	11.2
No	Landing Run Slope (%)	2.3	N/A	Flare Traversable RT	No
No	Landing Cross Slope (%)	2.2	Yes	DWS Provided	Yes
N/A	Landing Movement Obstructed?	Yes	Yes	DWS Contrast	Yes
	Landing Movement Type	Bushes	Yes	DWS Length (in)	36
N/A	Landing Shared	No	Yes	DWS Full Width	Yes
N/A	Clear Space	Yes	Yes	DWS Offset Left (in)	0
N/A	Clear Space To Crosswalk (in)	48	Yes	DWS Offset Right (in)	N/A
N/A	Marked Crosswalk 1	No	N/A	Marked Crosswalk 2	No
	Crossing 1 Direction	S		Crossing 2 Direction	E
	Marked Crosswalk 1 Width (in)	N/A		Marked Crosswalk 2 Width (in)	N/A

N/A	Ramp Inside Crosswalk 1	N/A	Yes	Ramp Inside Crosswalk 2	N/A
	Crossing 1 Slope (%)	0.6		Crossing 2 Slope (%)	4.9
	Crossing 1 Cross Slope (%)	0.4		Crossing 2 Cross Slope (%)	1.6
No	Gutter Ponding	Yes	Yes	Curb Slope	3.5
Yes	Gutter Lip Height (in)	0		Road Run Slope (%)	0.9
Yes	Gutter Run Slope (%)	0.5		Road Cross Slope (%)	0.4
No	Gutter Cross Slope (%)	3.5			
Yes	Overall Surface Condition:	Acceptable	Yes	Perp Joint Present	Yes
	Cross Gutter Present?	Yes		Spandrel Present?	Yes
	Replace Cross Gutter?	No		Replace Spandrel?	No

**Possible Solutions:**  
Remove & Replace Landing. Remove & Replace Gutter.
