# Access Compliance Report Public Rights-of-Way (Curb Ramps)

Main Street: RUSTIC\_LN Cross Street: KATELLA\_AVE Location: NE

ADA ID: RPRK210921112656 Ramp Type: Type 1 - Perpendicular Diagonal Initial Pass/Fail: Pass Overall Compliance: No Severity Score: 4

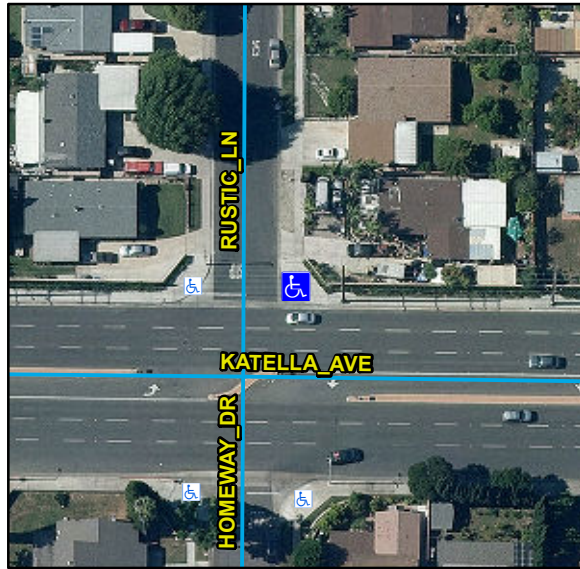
**Remove & Replace Landing. Gutter Ponding Observed.**

| Compliance | Description | Data | Compliance | Description | Data |
|---|---|---|---|---|---|
| No | Gutter Ponding | Yes | Yes | Curb Slope | 3.4 |

Possible Solutions:

**R304.2.1, R302.7, STD 1115**
