# Access Compliance Report Public Rights-of-Way (Curb Ramps)

Main Street: HOMEWAY\_DR Cross Street: KATELLA\_AVE Location: SW

ADA ID: RPRK210921113351 Ramp Type: Type 1 - Perpendicular Diagonal Initial Pass/Fail: Fail Overall Compliance: No Severity Score: 15

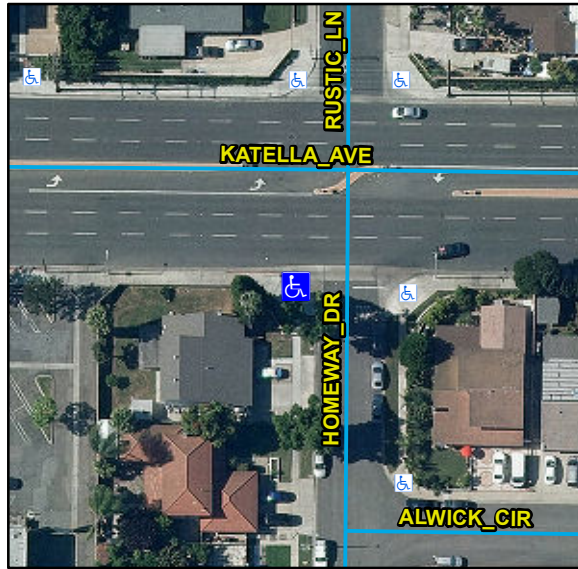
| Compliance | Description | Data | Compliance | Description | Data |
|---|---|---|---|---|---|
| No | Ramp Run Slope (%) | 8.8 | N/A | Flare Slope LT (%) | N/A |

**Remove & Replace Curb Ramp With Two New Directional Ramps or Equivalent.**

**R304.2.2, STD 1115**
