Access Compliance Report Public Rights-of-Way (Curb Ramps)

Main Street: KATELLA AVE **Cross Street: HOMEWAY DR** Location:

Overall Compliance: No ADA ID: RPRK210921113737 Ramp Type:Type 1 - Perpendicular Diagonal Initial Pass/Fail: Pass **Severity Score:**

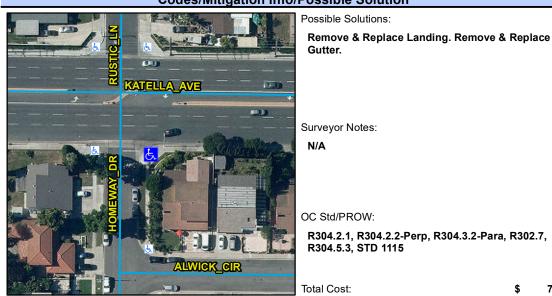
SE

Field Measurements/Component Compliance								
	Compliance Description		Data	Compliance Description		Data		
се	N/A	Ramp Length (in)	150	N/A	Flare Type LT			
	Yes	Ramp Width (in)	48			Sloped		
	Yes	Ramp Run Slope (%)	7	Yes	Flare Slope LT (%)	7.2		
	Yes	Ramp Cross Slope (%)	1.2	N/A	Flare Traversable LT	Yes		
	N/A	Landing Present	Yes	N/A	Flare Type RT			
	N/A	Landing Length (in)	38			Sloped		
	Yes	Landing Width (in)	48	N/A	Flare Slope RT (%)	8.8		
	No	Landing Run Slope (%)	2.6	N/A	Flare Traversable RT	No		
	Yes	Landing Cross Slope (%)	8.0	Yes	DWS Provided	Yes		
	N/A	Landing Movement Obstructed?	No	Yes	DWS Contrast	Yes		
		Landing Movement Type	N/A	Yes	DWS Length (in)	36		
7,	N/A	Landing Shared	No	Yes	DWS Full Width	Yes		
	N/A	Clear Space	Yes	Yes	DWS Offset Left (in)	0		
	N/A	Clear Space To Crosswalk (in)	48	Yes	DWS Offset Right (in)	N/A		
783	N/A	Marked Crosswalk 1	No	N/A	Marked Crosswalk 2	No		
		Crossing 1 Direction	N		Crossing 2 Direction	W

_AVE		Marked Crosswalk 1 Width (in)	N/A		Marked Crosswalk 2 Width (in)	N/A		
ntrol	N/A	Ramp Inside Crosswalk 1	N/A	Yes	Ramp Inside Crosswalk 2	N/A		
Y_DR		Crossing 1 Slope (%)	4.2		Crossing 2 Slope (%)	2.2		
Sign		Crossing 1 Cross Slope (%)	1.4		Crossing 2 Cross Slope (%)	1.9		
	No	Gutter Ponding	Yes	Yes	Curb Slope	0.1		
	Yes	Gutter Lip Height (in)	0		Road Run Slope (%)	2.2		
Data	Yes	Gutter Run Slope (%)	0.1		Road Cross Slope (%)	1.8		
Data No	No	Gutter Cross Slope (%)	2.6					
NO	Yes	Overall Surface Condition: Accep	otable	Yes	Perp Joint Present	Yes		
N/A		Cross Gutter Present?	Yes		Spandrel Present?	Yes		
N/A		Replace Cross Gutter?	No		Replace Spandrel?	No

Codes/Mitigation Info/Possible Solution
