# Access Compliance Report Public Rights-of-Way (Curb Ramps)

| Main Street: N/A | | Cross Street: KATELLA_AVE | | Location: | N |
| ADA ID: RPRK210921115130 | Ramp Type:Type 1 - Perpendicular | Initial Pass/Fail: Pass | Overall Compliance: No | Severity Score: | 0 |

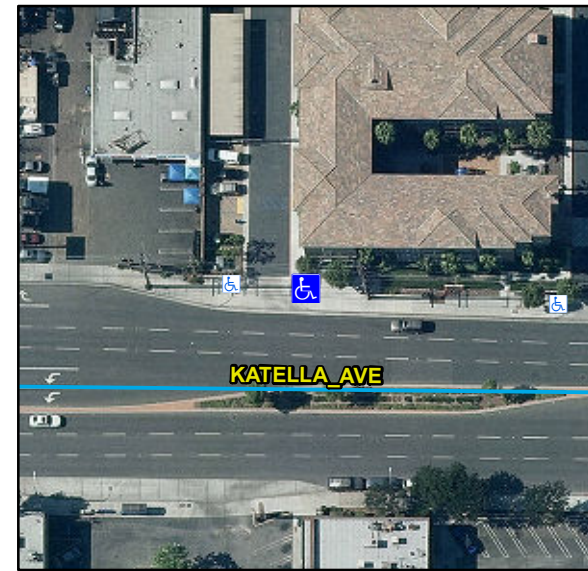
Gutter Ponding Observed.

| Compliance | Description | Data | Compliance | Description | Data |
|---|---|---|---|---|---|
| No | Gutter Ponding | Yes | Yes | Curb Slope | 0.1 |

Possible Solutions:

R302.7, STD 1115

\$ 252
