# Access Compliance Report Public Rights-of-Way (Curb Ramps)

| Main Street: N/A | | Cross Street: KATELLA_AVE | | Location: | N |
| ADA ID: RPRK210921115800 | Ramp Type:Type 1 - Perpendicular | Initial Pass/Fail: Pass | Overall Compliance: No | Severity Score: | 6 |

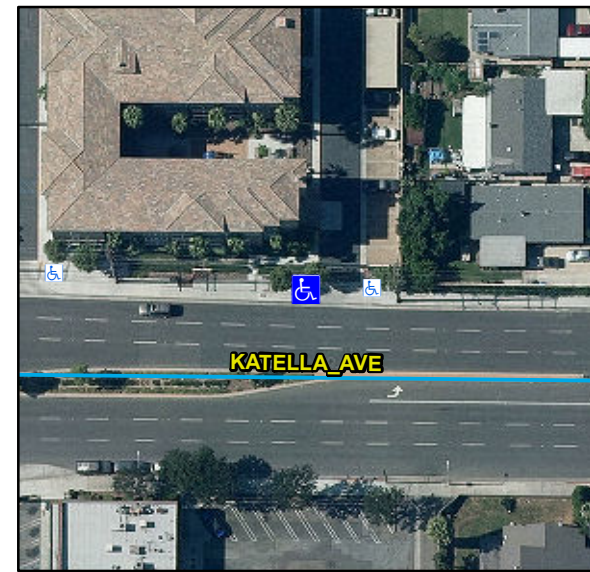
**Remove & Replace Landing. Gutter Ponding Observed.**

| Compliance | Description | Data | Compliance | Description | Data |
|---|---|---|---|---|---|
| No | Gutter Ponding | Yes | Yes | Curb Slope | 1.7 |

Possible Solutions:

**R304.2.1, R302.7, STD 1115**

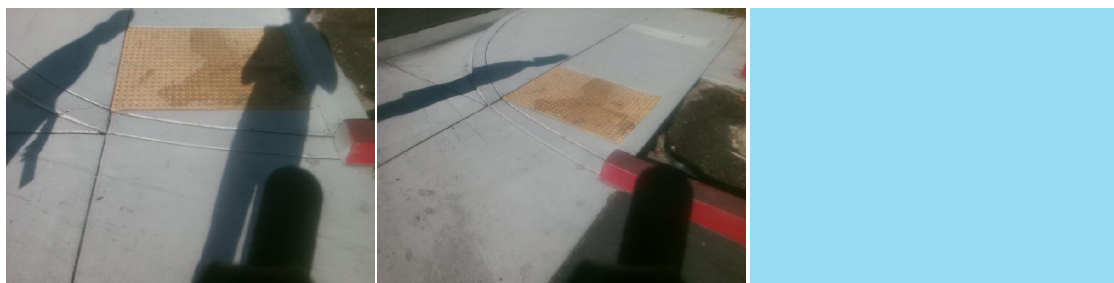
| Compliance | Description | Data | Compliance | Description | Data |
|---|---|---|---|---|---|
| Yes | Overall Surface Condition: Acceptable | | Yes | Perp Joint Present | Yes |
| | Cross Gutter Present? | Yes | | Spandrel Present? | Yes |
