# Access Compliance Report Public Rights-of-Way (Curb Ramps)

Main Street: N/A Cross Street: KATELLA\_AVE Location: N

ADA ID: RPRK210921120215 Ramp Type: Type 1 - Perpendicular Initial Pass/Fail: Pass Overall Compliance: No Severity Score: 0

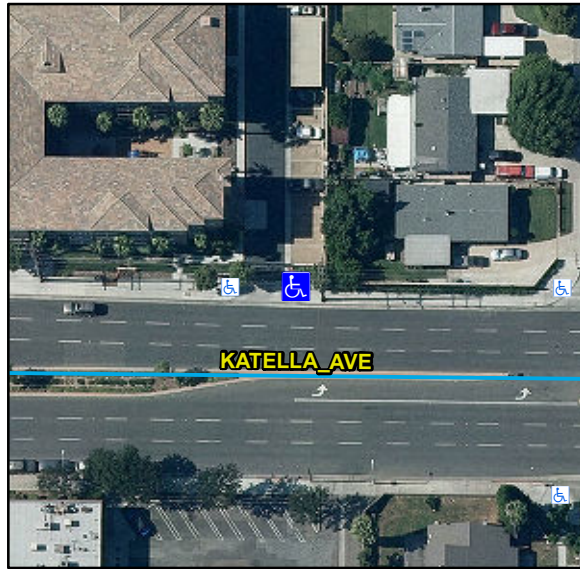
Remove & Replace Landing. Gutter Ponding Observed.

| Compliance | Description | Data | Compliance | Description | Data |
|---|---|---|---|---|---|
| No | Landing Cross Slope (%) | 3.3 | Yes | DWS Provided | Yes |
| No | Gutter Ponding | Yes | Yes | Curb Slope | 0.2 |

Possible Solutions:

R304.2.1, R304.5.3, R302.7, STD 1115

Total Cost: \$ 783
