# Access Compliance Report Public Rights-of-Way (Curb Ramps)

Main Street: N/A Cross Street: KATELLA\_AVE Location: N

ADA ID: RPRK210921120640 Ramp Type: Type 1 - Perpendicular Initial Pass/Fail: Pass Overall Compliance: No Severity Score: 2

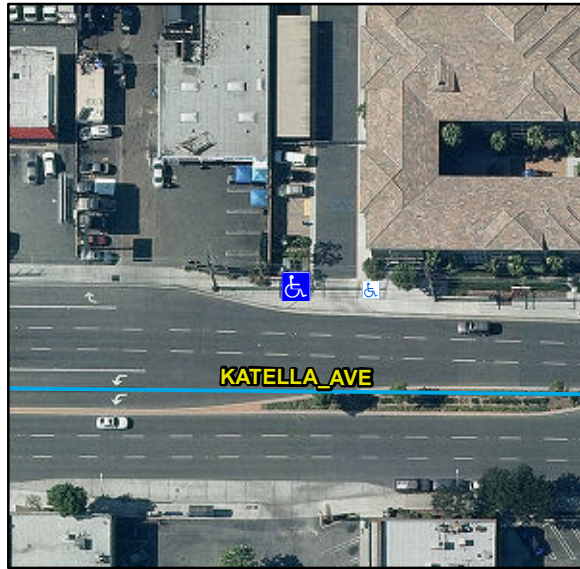
| Compliance | Description | Data | Compliance | Description | Data |
|---|---|---|---|---|---|
| N/A | Landing Movement Obstructed? | Yes | Yes | DWS Contrast | Yes |
| | Landing Movement Type | Bush | Yes | DWS Length (in) | 36 |
| No | Gutter Ponding | Yes | Yes | Curb Slope | 3.6 |

**Remove & Replace Landing. Gutter Ponding Observed.**

**R304.2.1, R302.7, STD 1115**

Total Cost: \$ 783
