Access Compliance Report Public Rights-of-Way (Curb Ramps)

Main Street: MAGNOLIA_AVE **Cross Street:** KATELLA_AVE **Location:** NE

ADA ID: RPRK210921121204 **Ramp Type:**Type 1 - Perpendicular Diagonal Initial Pass/Fail: Pass **Overall Compliance:** No **Severity Score:** 0

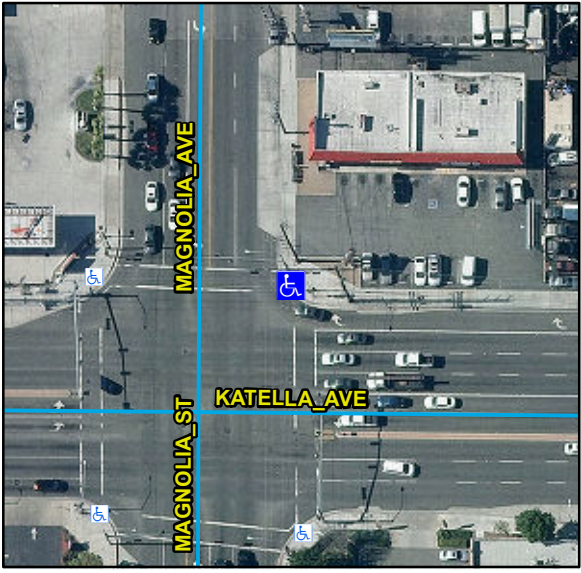
Compliance	Description	Data	Compliance	Description	Data
N/A	Ramp Length (in)	115	N/A	Flare Type LT	
Yes	Ramp Width (in)	48			Sloped
Yes	Ramp Run Slope (%)	5.1	N/A	Flare Slope LT (%)	6.1
Yes	Ramp Cross Slope (%)	1.1	N/A	Flare Traversable LT	No
N/A	Landing Present	Yes	N/A	Flare Type RT	
N/A	Landing Length (in)	48			Sloped
Yes	Landing Width (in)	48	N/A	Flare Slope RT (%)	7.3
No	Landing Run Slope (%)	2.6	N/A	Flare Traversable RT	No
Yes	Landing Cross Slope (%)	1.7	Yes	DWS Provided	Yes
N/A	Landing Movement Obstructed?	No	Yes	DWS Contrast	Yes
	Landing Movement Type	N/A	Yes	DWS Length (in)	36
N/A	Landing Shared	No	Yes	DWS Full Width	Yes
Yes	Clear Space	Yes	Yes	DWS Offset Left (in)	0
Yes	Clear Space To Crosswalk (in)	48	Yes	DWS Offset Right (in)	N/A
N/A	Marked Crosswalk 1	Yes	N/A	Marked Crosswalk 2	Yes
	Crossing 1 Direction	W		Crossing 2 Direction	S
	Marked Crosswalk 1 Width (in)	120		Marked Crosswalk 2 Width (in)	120

Yes	Ramp Inside Crosswalk 1	Yes	Yes	Ramp Inside Crosswalk 2	Yes
	Crossing 1 Slope (%)	0.6		Crossing 2 Slope (%)	1
	Crossing 1 Cross Slope (%)	2.8		Crossing 2 Cross Slope (%)	3.8
No	Gutter Ponding	Yes	Yes	Curb Slope	3
Yes	Gutter Lip Height (in)	0		Road Run Slope (%)	3.9
Yes	Gutter Run Slope (%)	0.1		Road Cross Slope (%)	0.3
Yes	Gutter Cross Slope (%)	2.8			
Yes	Overall Surface Condition: Acceptable		Yes	Perp Joint Present	Yes
	Cross Gutter Present?	No		Spandrel Present?	No
	Replace Cross Gutter?	N/A		Replace Spandrel?	N/A

Possible Solutions:
Remove & Replace Landing. Gutter Ponding Observed.
