# Access Compliance Report Public Rights-of-Way (Curb Ramps)

Main Street: N/A Cross Street: KATELLA\_AVE Location: NE

ADA ID: RPRK210921132955 Ramp Type: Type 1 - Perpendicular Initial Pass/Fail: Pass Overall Compliance: No Severity Score: 0

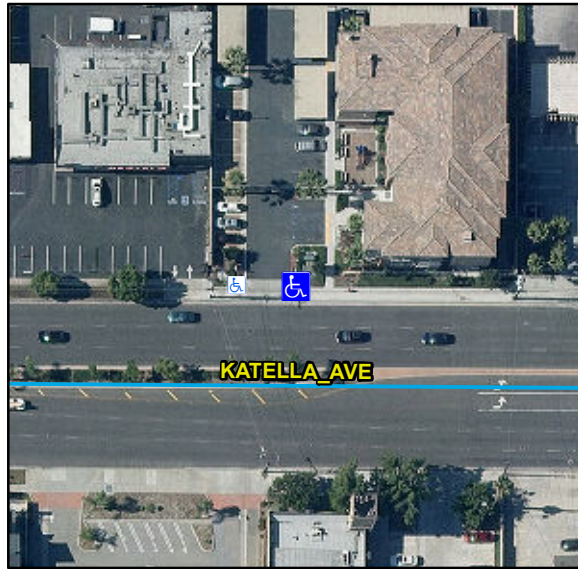
Gutter Ponding Observed.

| Compliance | Description | Data | Compliance | Description | Data |
|---|---|---|---|---|---|
| No | Gutter Ponding | Yes | Yes | Curb Slope | 2.6 |

R302.7, STD 1115

\$ 252
