# Access Compliance Report

### (Curb Ramps)

Main Street: N/A Cross Street: KATELLA\_AVE Location: NW

ADA ID: RPRK210921133420 Ramp Type: Type 1 - Perpendicular Initial Pass/Fail: Pass Overall Compliance: No Severity Score: 0

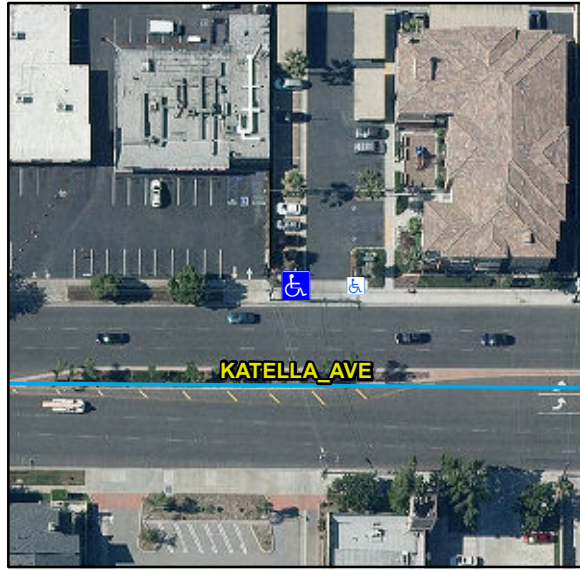
Gutter Ponding Observed.

| Compliance | Description | Data | Compliance | Description | Data |
|---|---|---|---|---|---|
| No | Gutter Ponding | Yes | Yes | Curb Slope | 0.5 |

Possible Solutions:

R302.7, STD 1115

\$ 252
