# Access Compliance Report Public Rights-of-Way (Curb Ramps)

Main Street: MAC\_ST Cross Street: KATELLA\_AVE Location: NE

ADA ID: RPRK210921141543 Ramp Type: Type 1 - Perpendicular Diagonal Initial Pass/Fail: Pass Overall Compliance: No Severity Score: 0

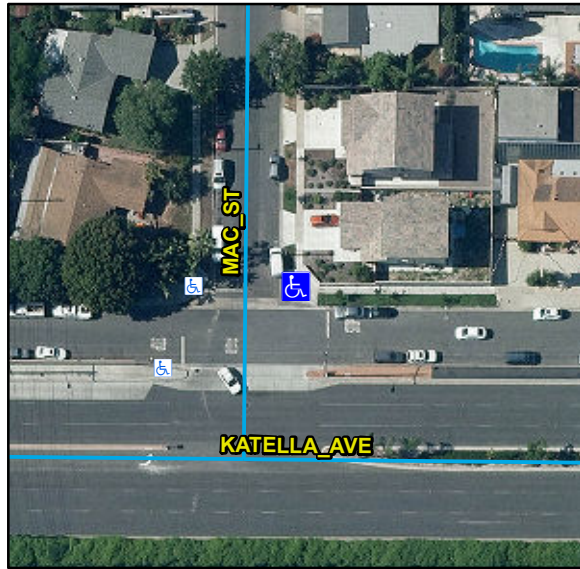
**Remove & Replace Landing. Gutter Ponding Observed.**

| Compliance | Description | Data | Compliance | Description | Data |
|---|---|---|---|---|---|
| No | Gutter Ponding | Yes | Yes | Curb Slope | 1.6 |

Possible Solutions:

R304.2.1, R302.7, STD 1115

Total Cost: \$ 783
