# Access Compliance Report Public Rights-of-Way (Curb Ramps)

Main Street: KATELLA\_AVE Cross Street: MAC\_ST Location: NW

ADA ID: RPRK210921142303 Ramp Type: Type 4 - Parallel Initial Pass/Fail: Pass Overall Compliance: No Severity Score: 4

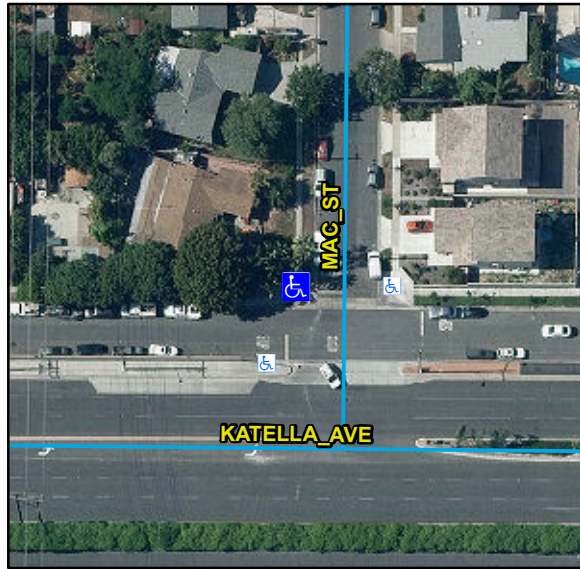
| Compliance | Description | Data | Compliance | Description | Data |
|---|---|---|---|---|---|
| Yes | Ramp Width LT (in) | 48 | No | Ramp Width RT (in) | 40 |
| No | Gutter Cross Slope (%) | 3.9 | No | Perpendicular Joint Present | No |

**Remove & Replace Curb Ramp With Two New Directional Ramps or Equivalent. Remove & Replace Gutter.**

**R204.3, R304.5.1, R304.5.3, STD 1115**
