# Access Compliance Report Public Rights-of-Way (Curb Ramps)

Main Street: REGAL\_AVE Cross Street: MAC\_ST Location: SE

ADA ID: RPRK210921143836 Ramp Type: Type 1 - Perpendicular Diagonal Initial Pass/Fail: Fail Overall Compliance: No Severity Score: 2

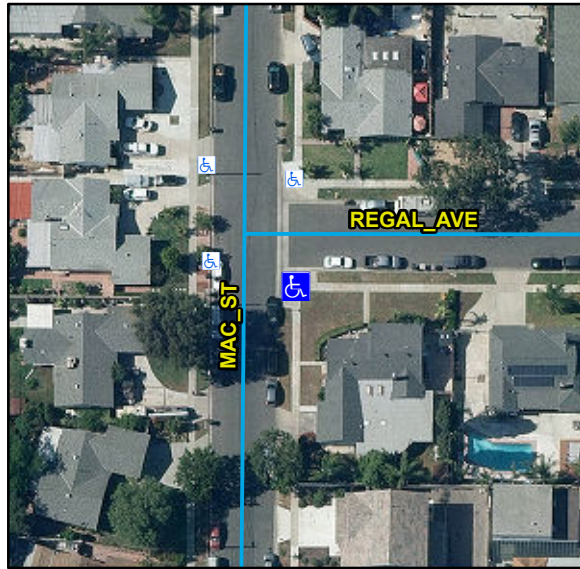
| Compliance | Description | Data | Compliance | Description | Data |
|---|---|---|---|---|---|
| No | Ramp Cross Slope (%) | 4.7 | N/A | Flare Traversable LT | N/A |

Remove & Replace Curb Ramp With Two New Directional Ramps or Equivalent.

R304.5.3, STD 1115
