# Access Compliance Report Public Rights-of-Way (Curb Ramps)

**Main Street:** MAC\_ST **Cross Street:** REGAL\_AVE **Location:** NE

**ADA ID:** RPRK210921144305 **Ramp Type:**Type 1 - Perpendicular Diagonal Initial Pass/Fail: Pass **Overall Compliance:** No **Severity Score:** 10

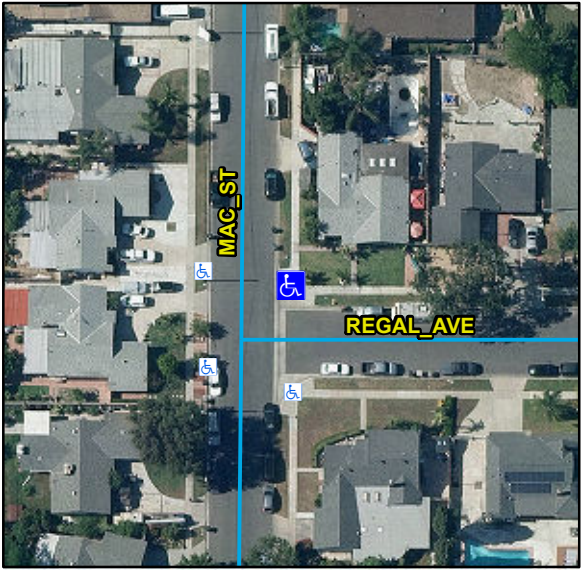
Compliance	Description	Data	Compliance	Description	Data
N/A	Ramp Length (in)	51	N/A	Flare Type LT	
Yes	Ramp Width (in)	48			Sloped
Yes	Ramp Run Slope (%)	6.8	N/A	Flare Slope LT (%)	4.6
Yes	Ramp Cross Slope (%)	0.1	N/A	Flare Traversable LT	No
N/A	Landing Present	No	N/A	Flare Type RT	
N/A	Landing Length (in)	N/A			Sloped
No	Landing Width (in)	N/A	N/A	Flare Slope RT (%)	6.3
No	Landing Run Slope (%)	N/A	N/A	Flare Traversable RT	No
No	Landing Cross Slope (%)	N/A	Yes	DWS Provided	Yes
N/A	Landing Movement Obstructed?	Yes	Yes	DWS Contrast	Yes
	Landing Movement Type	Curb	Yes	DWS Length (in)	36
N/A	Landing Shared	N/A	Yes	DWS Full Width	Yes
N/A	Clear Space	Yes	Yes	DWS Offset Left (in)	0
N/A	Clear Space To Crosswalk (in)	48	Yes	DWS Offset Right (in)	N/A
N/A	Marked Crosswalk 1	No	N/A	Marked Crosswalk 2	No
	Crossing 1 Direction	W		Crossing 2 Direction	S
	Marked Crosswalk 1 Width (in)	N/A		Marked Crosswalk 2 Width (in)	N/A

N/A	Ramp Inside Crosswalk 1	N/A	Yes	Ramp Inside Crosswalk 2	N/A
	Crossing 1 Slope (%)	4.7		Crossing 2 Slope (%)	0.5
	Crossing 1 Cross Slope (%)	1.7		Crossing 2 Cross Slope (%)	2.6
Yes	Gutter Ponding	No	Yes	Curb Slope	4
Yes	Gutter Lip Height (in)	0		Road Run Slope (%)	1.3
Yes	Gutter Run Slope (%)	0.5		Road Cross Slope (%)	0.9
No	Gutter Cross Slope (%)	4.1			
Yes	Overall Surface Condition: <b>Acceptable</b>		Yes	Perp Joint Present	Yes
	Cross Gutter Present?	Yes		Spandrel Present?	Yes
	Replace Cross Gutter?	No		Replace Spandrel?	No

**Possible Solutions:**  
Install Landing. Remove & Replace Gutter.
