# Access Compliance Report Public Rights-of-Way (Curb Ramps)

Main Street: SYRACUSE\_AVE Cross Street: MACMURRAY\_ST Location: SE

ADA ID: RPRK210921150931 Ramp Type: Type 1 - Perpendicular Diagonal Initial Pass/Fail: Fail Overall Compliance: No Severity Score: 15

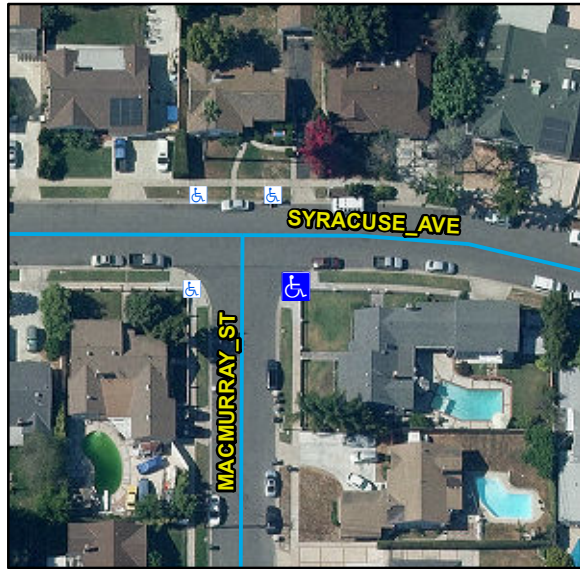
| Compliance | Description | Data | Compliance | Description | Data |
|---|---|---|---|---|---|
| No | Ramp Cross Slope (%) | 6.6 | N/A | Flare Traversable LT | N/A |

Remove & Replace Curb Ramp With Two New Directional Ramps or Equivalent.

R204.3, R304.5.3, STD 1115
