# Access Compliance Report Public Rights-of-Way (Curb Ramps)

Main Street: MACMURRAY\_ST Cross Street: SYRACUSE\_AVE Location: SW

ADA ID: RPRK210921151300 Ramp Type: Type 1 - Perpendicular Diagonal Initial Pass/Fail: Pass Overall Compliance: No Severity Score: 10

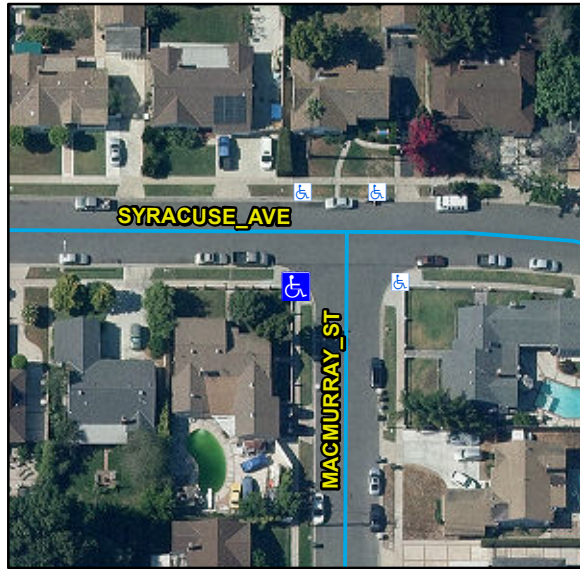
| Compliance | Description | Data | Compliance | Description | Data |
|---|---|---|---|---|---|
| No | Landing Width (in) | N/A | N/A | Flare Slope RT (%) | 6.4 |
| No | Landing Run Slope (%) | N/A | N/A | Flare Traversable RT | No |
| No | Landing Cross Slope (%) | N/A | Yes | DWS Provided | Yes |
| No | Gutter Ponding | Yes | No | Curb Slope | 6.3 |
| No | Gutter Cross Slope (%) | 8.6 | | | |

Remove & Replace Curb Ramp With Two New Directional Ramps or Equivalent. Remove & Replace Gutter.

R304.2.2, R204.3, R304.2.1, R304.2.2-Perp, R304.3.2-Para, R304.5.3, R302.7, STD 1115
