# Access Compliance Report Public Rights-of-Way (Curb Ramps)

Main Street: MAC\_ST Cross Street: SYRACUSE\_AVE Location: NE

ADA ID: RPRK210921151951 Ramp Type: Type 1 - Perpendicular Diagonal Initial Pass/Fail: Fail Overall Compliance: No Severity Score: 2

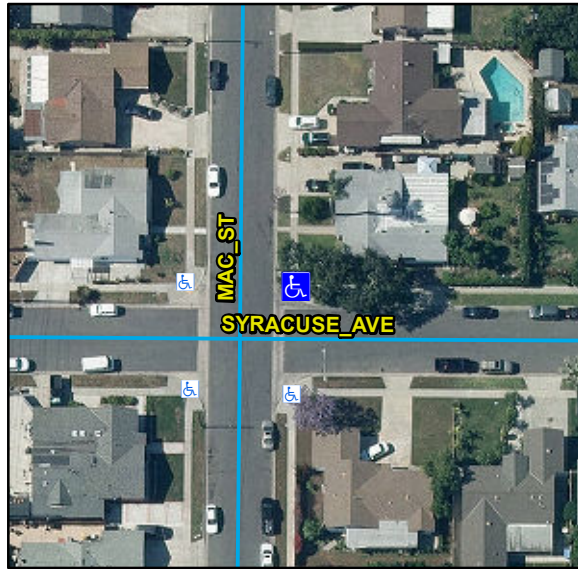
| Compliance | Description | Data | Compliance | Description | Data |
|---|---|---|---|---|---|
| No | Ramp Cross Slope (%) | 2.3 | N/A | Flare Traversable LT | N/A |

Remove & Replace Curb Ramp With Two New Directional Ramps or Equivalent.

R304.5.3, STD 1115
