# Access Compliance Report Public Rights-of-Way (Curb Ramps)

Main Street: SYRACUSE\_AVE Cross Street: MAC\_ST Location: NW

ADA ID: RPRK210921152233 Ramp Type: Type 1 - Perpendicular Diagonal Initial Pass/Fail: Fail Overall Compliance: No Severity Score: 15

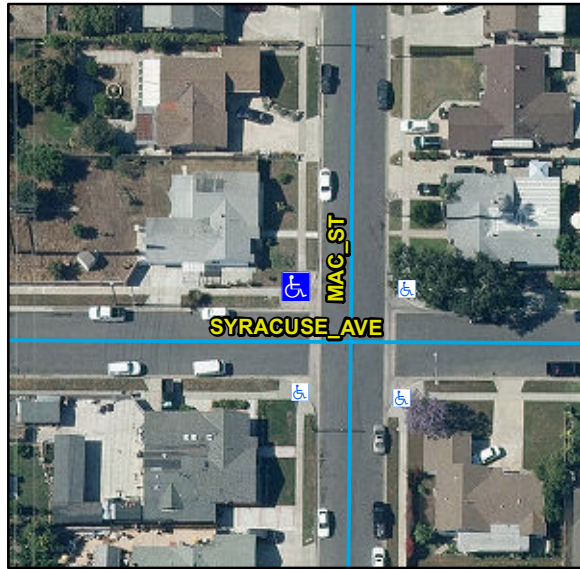
| Compliance | Description | Data | Compliance | Description | Data |
|---|---|---|---|---|---|
| No | Ramp Cross Slope (%) | 5.1 | N/A | Flare Traversable LT | N/A |
| N/A | Gutter Ponding | N/A | No | Curb Slope | 5.7 |

Remove & Replace Curb Ramp With Two New Directional Ramps or Equivalent.

R304.2.2, R304.5.3, STD 1115
