# Access Compliance Report Public Rights-of-Way (Curb Ramps)

Main Street: MAC\_ST Cross Street: SYRACUSE\_AVE Location: SW

ADA ID: RPRK210921152557 Ramp Type: Type 1 - Perpendicular Diagonal Initial Pass/Fail: Fail Overall Compliance: No Severity Score: 2

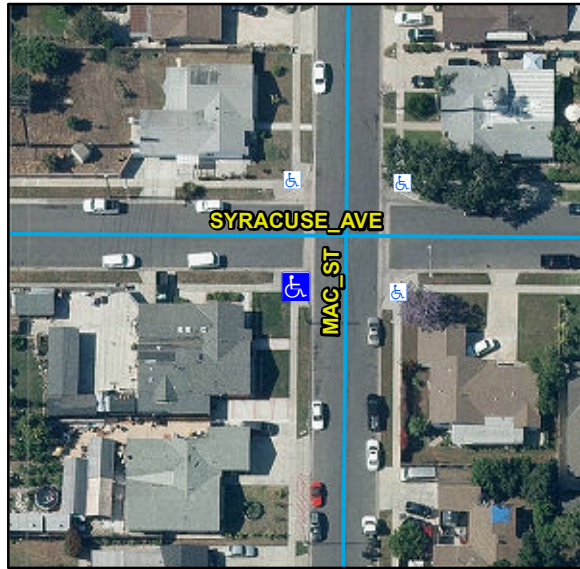
| Compliance | Description | Data | Compliance | Description | Data |
|---|---|---|---|---|---|
| No | Ramp Cross Slope (%) | 4.4 | N/A | Flare Traversable LT | N/A |

**Remove & Replace Curb Ramp With Two New Directional Ramps or Equivalent.**

**R304.5.3, STD 1115**
