# Access Compliance Report Public Rights-of-Way (Curb Ramps)

Main Street: SYRACUSE\_AVE Cross Street: MAC\_ST Location: SE

ADA ID: RPRK210921152859 Ramp Type: Type 1 - Perpendicular Diagonal Initial Pass/Fail: Fail Overall Compliance: No Severity Score: 2

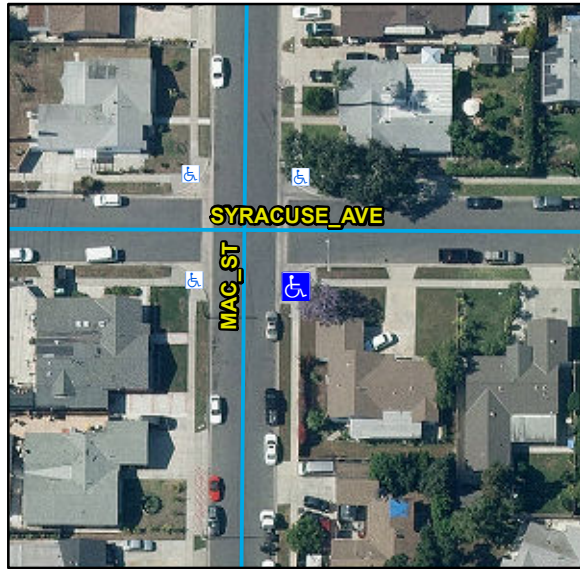
| Compliance | Description | Data | Compliance | Description | Data |
|---|---|---|---|---|---|
| No | Ramp Cross Slope (%) | 4.1 | N/A | Flare Traversable LT | N/A |

**Remove & Replace Curb Ramp With Two New Directional Ramps or Equivalent.**

**R304.5.3, STD 1115**
