# Access Compliance Report Public Rights-of-Way (Curb Ramps)

Main Street: MAGNOLIA\_AVE Cross Street: MAGNOLIA\_AVE Location: E

ADA ID: RPRK210921160751 Ramp Type: Type 4 - Parallel Initial Pass/Fail: Fail Overall Compliance: No Severity Score: 30

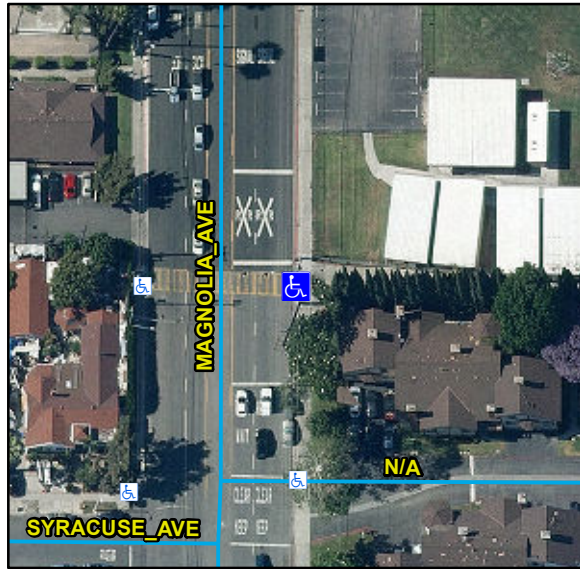
| Compliance | Description | Data | Compliance | Description | Data |
|---|---|---|---|---|---|
| No | Ramp Cross Slope LT (%) | 7.8 | No | Ramp Cross Slope RT (%) | 4.4 |

Remove & Replace Entire Ramp.

R304.5.3, STD 1115
