# Access Compliance Report Public Rights-of-Way (Curb Ramps)

Main Street: VINEVALE\_ST Cross Street: PACIFIC\_AVE Location: NE

ADA ID: RPRK210921172352 Ramp Type: Type 1 - Perpendicular Diagonal Initial Pass/Fail: Fail Overall Compliance: No Severity Score: 2

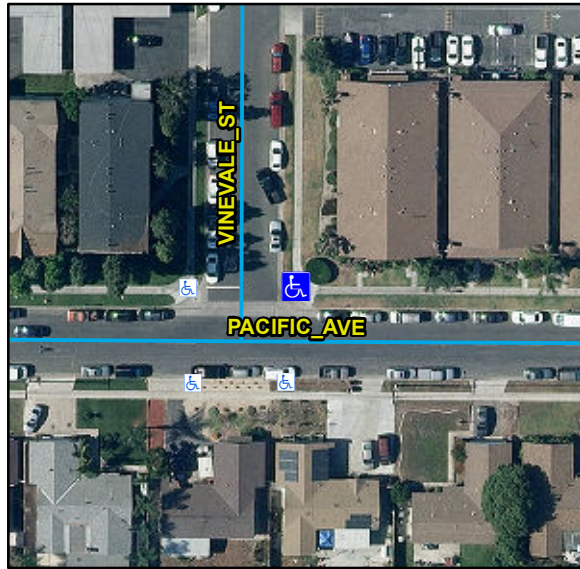
| Compliance | Description | Data | Compliance | Description | Data |
|---|---|---|---|---|---|
| No | Ramp Cross Slope (%) | 2.2 | N/A | Flare Traversable LT | N/A |
| N/A | Gutter Ponding | N/A | No | Curb Slope | 8.2 |

Remove & Replace Curb Ramp With Two New Directional Ramps or Equivalent.

R304.2.2, R304.5.3, STD 1115
