# Access Compliance Report Public Rights-of-Way (Curb Ramps)

Main Street: PACIFIC\_AVE Cross Street: VINEVALE\_ST Location: NW

ADA ID: RPRK210921172909 Ramp Type: Type 1 - Perpendicular Diagonal Initial Pass/Fail: Fail Overall Compliance: No Severity Score: 15

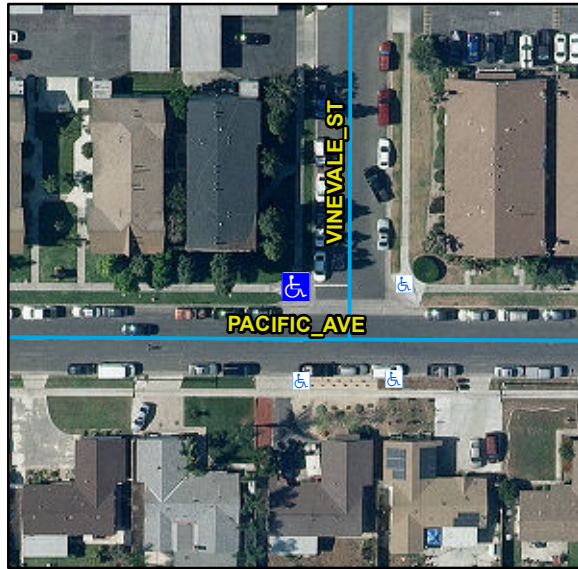
| Compliance | Description | Data | Compliance | Description | Data |
|---|---|---|---|---|---|
| No | Ramp Run Slope (%) | 9 | N/A | Flare Slope LT (%) | N/A |

**Remove & Replace Curb Ramp With Two New Directional Ramps or Equivalent.**

**R304.2.2, STD 1115**
