# Access Compliance Report Public Rights-of-Way (Curb Ramps)

Main Street: **RODEO\_DR** Cross Street: **PACIFIC\_AVE** Location: **NE**

ADA ID: **RPRK210921181548** Ramp Type: **Type 1 - Perpendicular Diagonal Initial Pass/Fail: Pass** Overall Compliance: **No** Severity Score: **0**

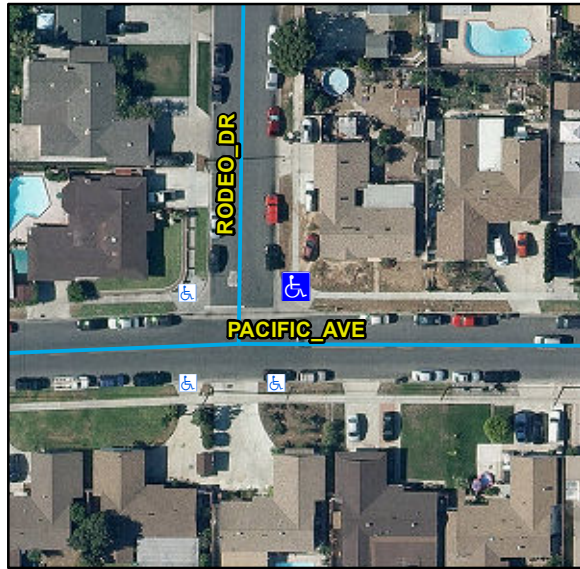
| Compliance | Description | Data | Compliance | Description | Data |
|---|---|---|---|---|---|
| <b>N/A</b> | Landing Movement Obstructed? | <b>Yes</b> | <b>Yes</b> | DWS Contrast | <b>Yes</b> |
| <b>No</b> | Gutter Cross Slope (%) | <b>3.3</b> | | | |

**Remove & Replace Landing. Remove & Replace Gutter.**

**R304.2.1, R304.5.3, STD 1115**
