# Access Compliance Report Public Rights-of-Way (Curb Ramps)

Main Street: TINA WAY Cross Street: RODEO DR Location: SE

ADA ID: RPRK210921182244 Ramp Type: Type 1 - Perpendicular Diagonal Initial Pass/Fail: Pass Overall Compliance: No Severity Score: 0

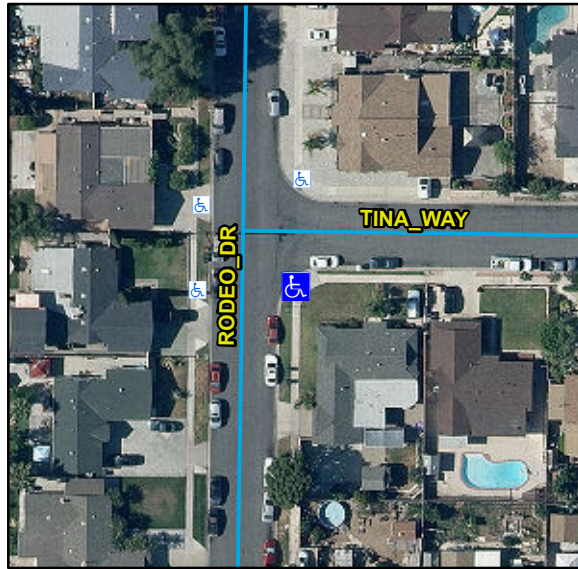
| Compliance | Description | Data | Compliance | Description | Data |
|---|---|---|---|---|---|
| No | Gutter Ponding | Yes | No | Curb Slope | 5.3 |
| No | Gutter Cross Slope (%) | 2.1 | | | |

Remove & Replace Curb Ramp With Two New Directional Ramps or Equivalent. Remove & Replace Gutter.

R304.2.2, R304.2.1, R302.7, R304.5.3, STD 1115
